**Preliminary Investigation into the Collapse
of a Balcony at 598 Castle Street, Dunedin**

March 2016

STUDENT ACCOMMODATION
CUMBERLAND STREET DUNEDIN

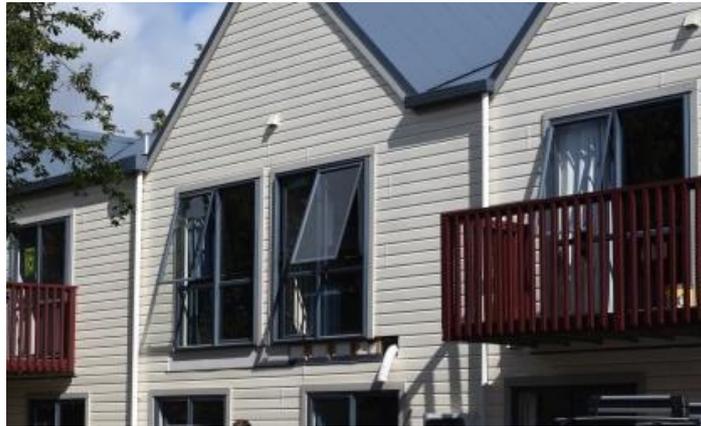
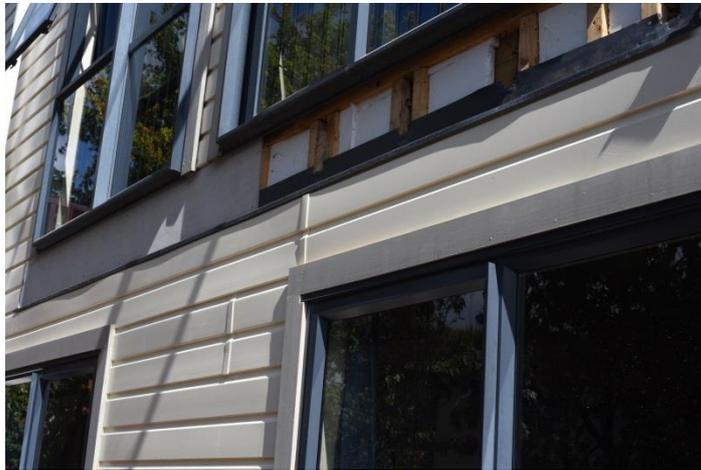
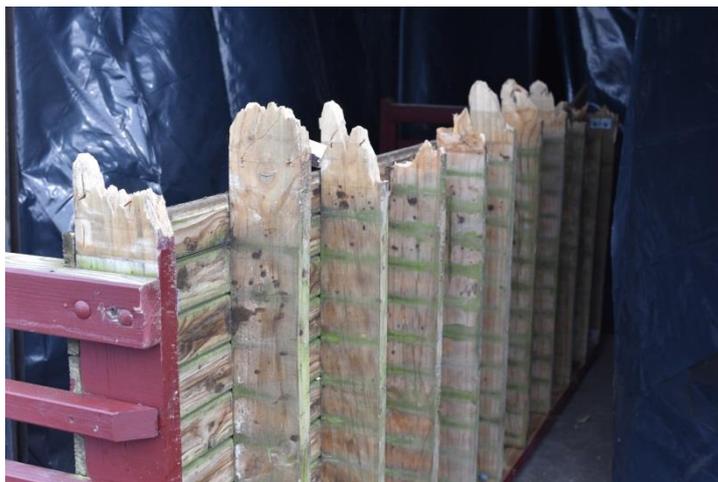
Appendix B Selection of Photographs

The balcony remnant comprised a complete balcony floor with all the joists severed at the wall face. The balustrade along the front and one side of the balcony had broken away. No evidence of decay or deterioration of the wood in any of the joists in the vicinity of the fractures was observed during the 7 March 2016 site visit by MBIE.

It is not yet clear to what extent the failure of the balcony joists may have been contributed to by the notches in the joists at the junction between the floor of the building and the balcony. The joists fractured at the location of the step change in the depth of the joist, from 190 mm beneath the flooring inside the building to 140 mm beneath the balcony deck. This step or notch detail is permitted by the Timber Framed Buildings Standard NZS 3604: 1990, although there are no explicit criteria or guidance on the permissible depth of the notch for cantilevered floor joists supporting a balcony. The current NZS 3604: 2011 also permits this detail, with no explicit guidance on permitted notch dimensions.

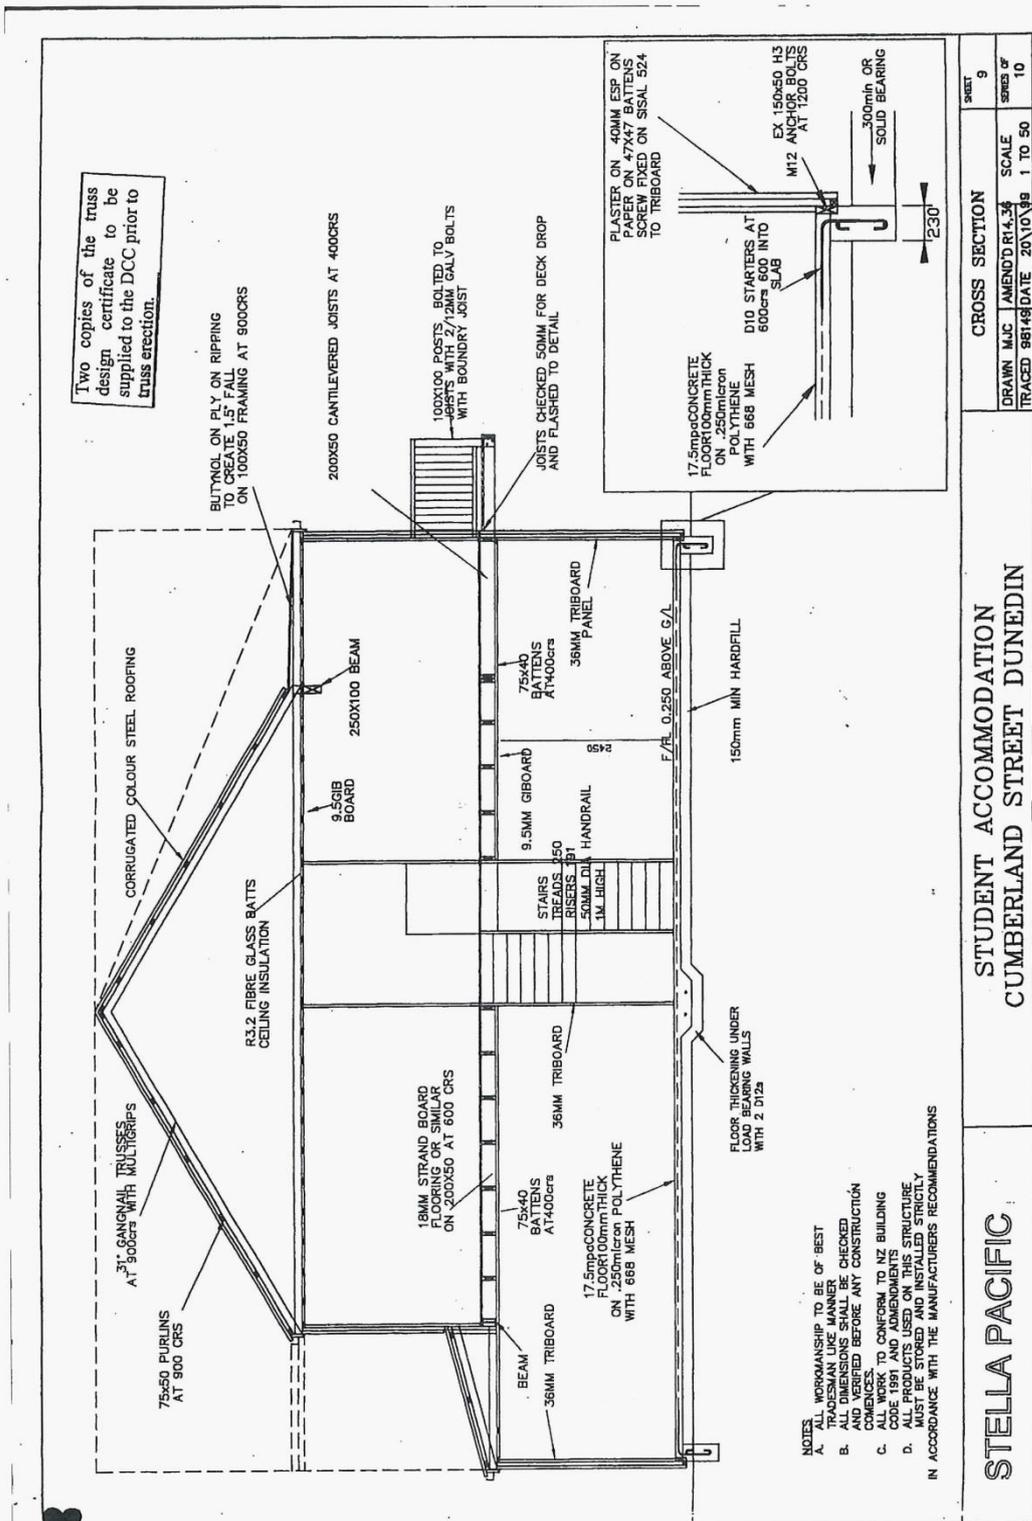
A review of the relevant consent drawings (Appendix C) indicates the balcony was designed with eleven cantilevered joists spaced at 400 mm centres, projecting 1200 mm from the external face of the building framing and extending 1800 mm into the floor to double floor joists running at right angles to the balcony's joists. The drawings show the joists as continuous nominal 200 mm x 50 mm members. The finished size of the joists was measured as 190 mm x 45 mm with a 50 mm step down that reduces the size to 140 mm x 45 mm.

200X50 CANTILEVERED JOISTS AT 400CRS

JOISTS CHECKED 50MM FOR DECK DROP AND FLASHED TO DETAIL
